**National Sedimentation Laboratory
Channel and Watershed Processes Research Unit
Oxford, Mississippi**

Acoustic Imaging of Sediment Impounded Within USDA-NRCS Flood Control Dams, Wisconsin

By John A. Dunbar, Paul D. Higley, and Sean J. Bennett

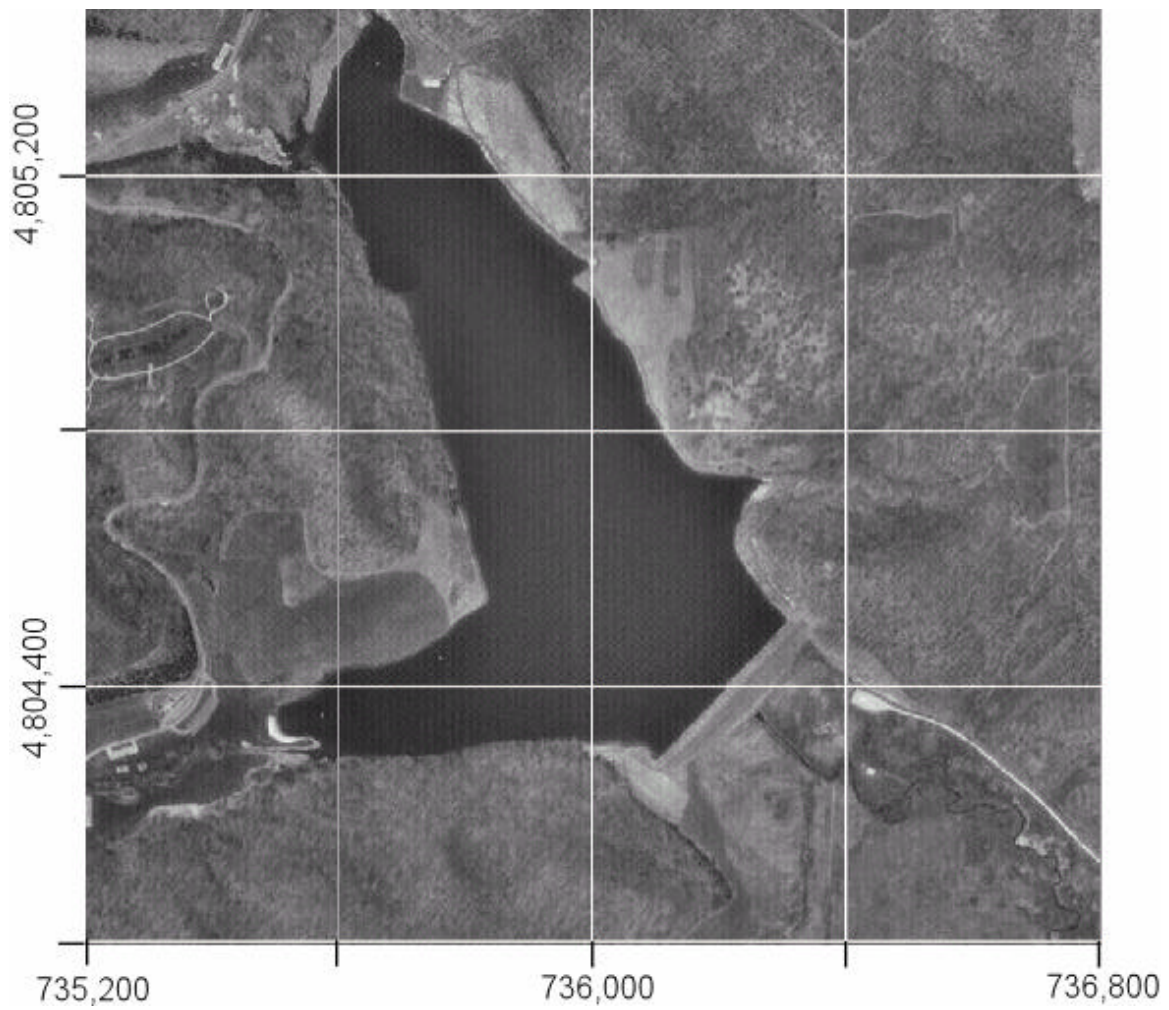
Figure 2-2. Orthographic composite photograph of White Mound Lake, WI. Coordinates are in meters (UTM Zone 15).

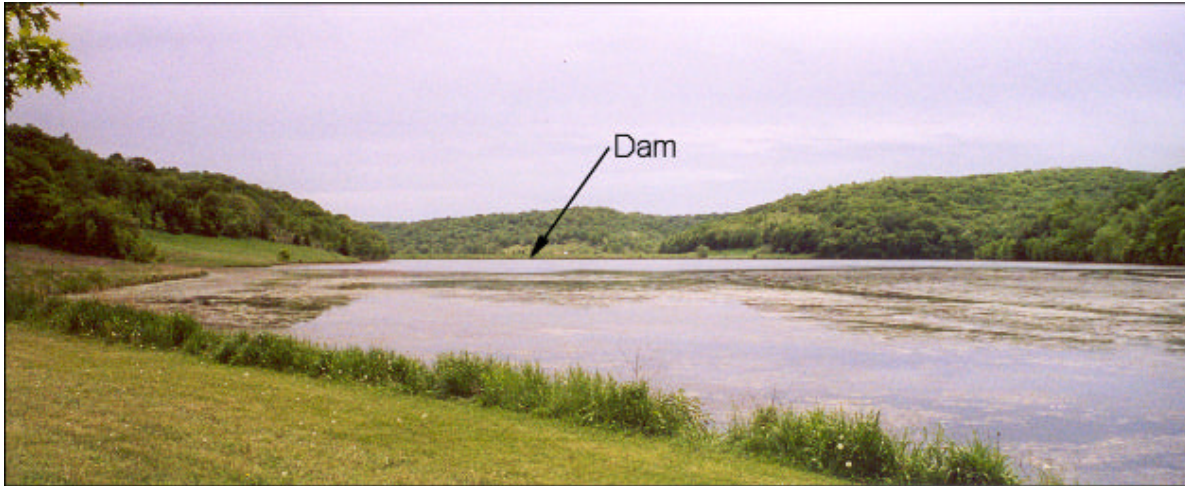
Figure 2-3. The photograph of White Mound Lake taken from the boat ramp area and facing south. Areas of the lake with 4 m of water depth or less contain aquatic vegetation that extends from the bottom to the lake surface as shown in distance.

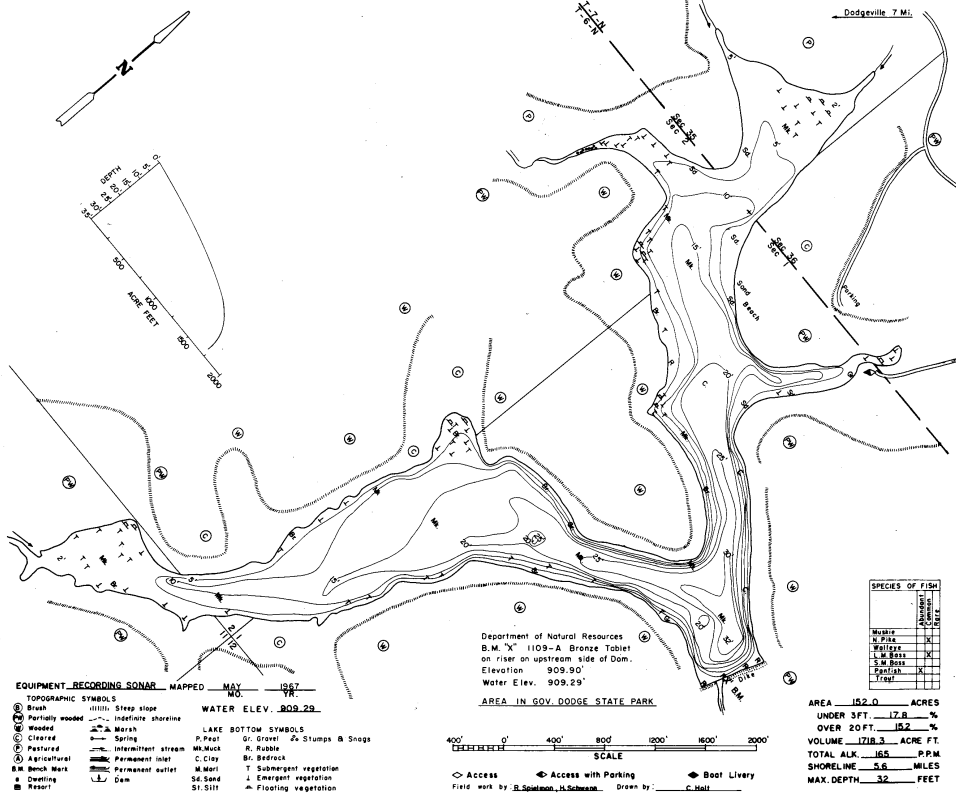
Figure 2-4. 1967 base map of Twin Valley Lake (from Wisconsin Department of Natural Resources).

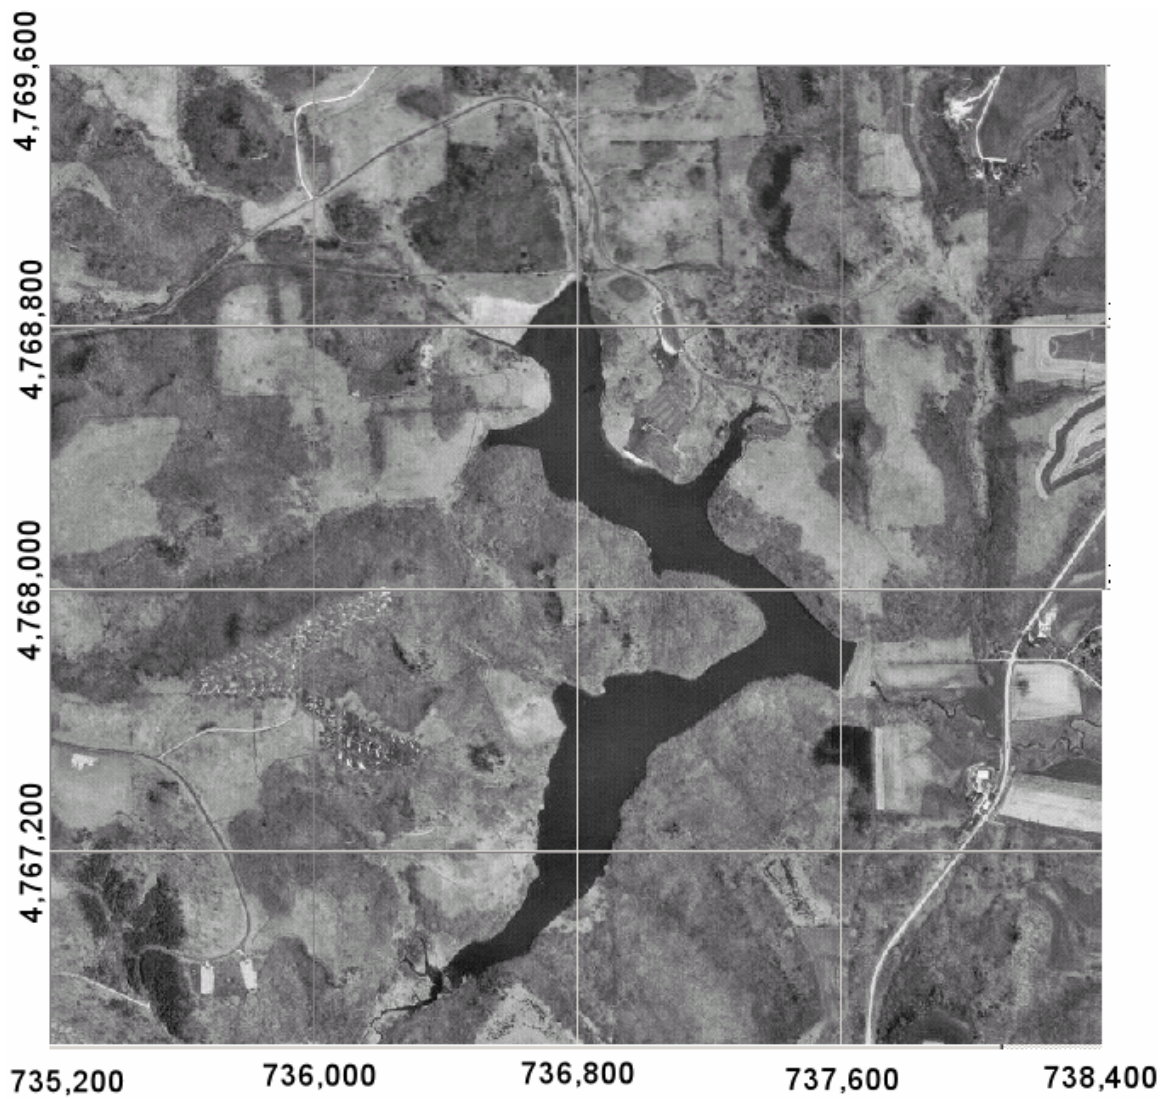
Figure 2-5. Orthographic composite photograph of Twin Valley Lake, WI. Coordinates are in meters (UTM Zone 15).

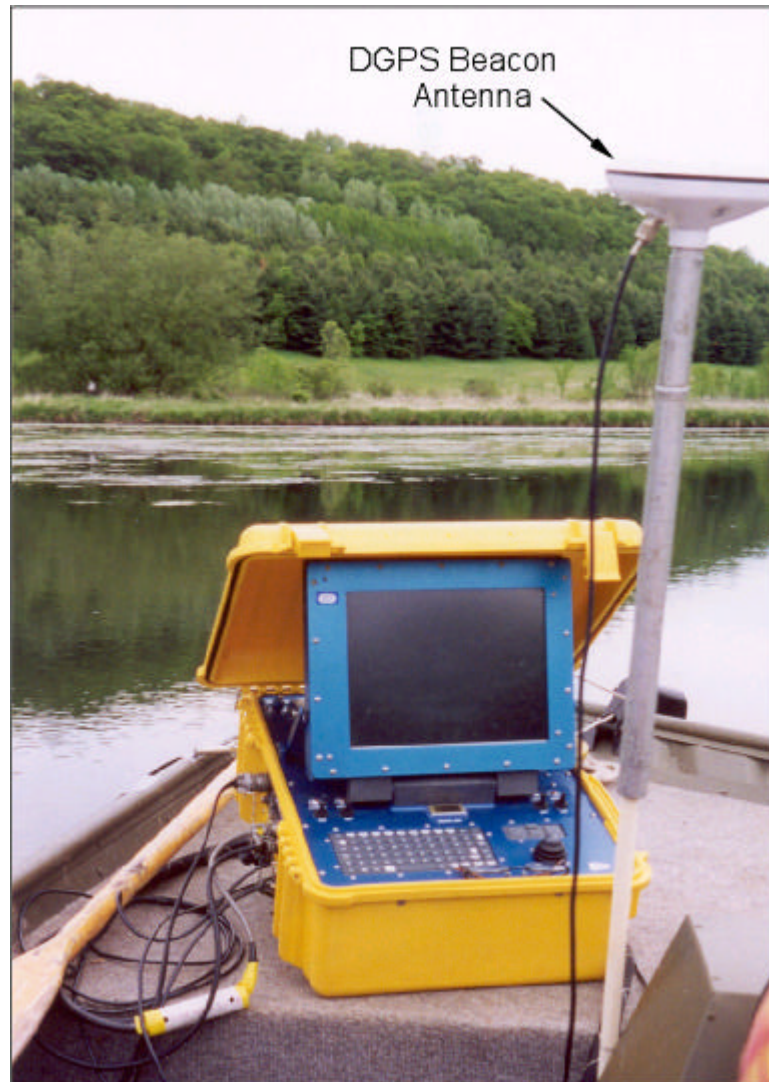
Figure 3-1. Photograph of acoustic profiler control module. All acoustic profiling and DGPS navigation electronics are contained in a compact, water-resistant control module.

The acoustic profiling system used herein was developed in a collaboration between Baylor University and Specialty Devices, Inc., Plano, TX (SDI; Dunbar, et al., 1999; Figures 3-1 and 3-2). The system was designed for sediment surveys of large water supply reservoirs, but the commercialized version has been used to survey lakes, harbors, and rivers as well. The prototype electronics module includes one computer that controls the acoustic profiling, another that controls navigation, a built-in computer monitor, and a differential GPS navigation system. All of these components are contained in one, suitcase-sized water-resistant box. The prototype module weighs 15 kg. In the commercialized version, both subsurface profiling and navigation operations are controlled by a single, faster computer, resulting in an electronics module that is smaller and lighter. Power for the electronics and acoustic source is supplied by a 12-volt marine battery. Depending on the number and type of acoustic transducers used, the sound source may weigh between 15 and 30 kg. Hence, even though the system was designed for large reservoir surveys, deployment in small floodwater retention reservoirs is logistically practical.

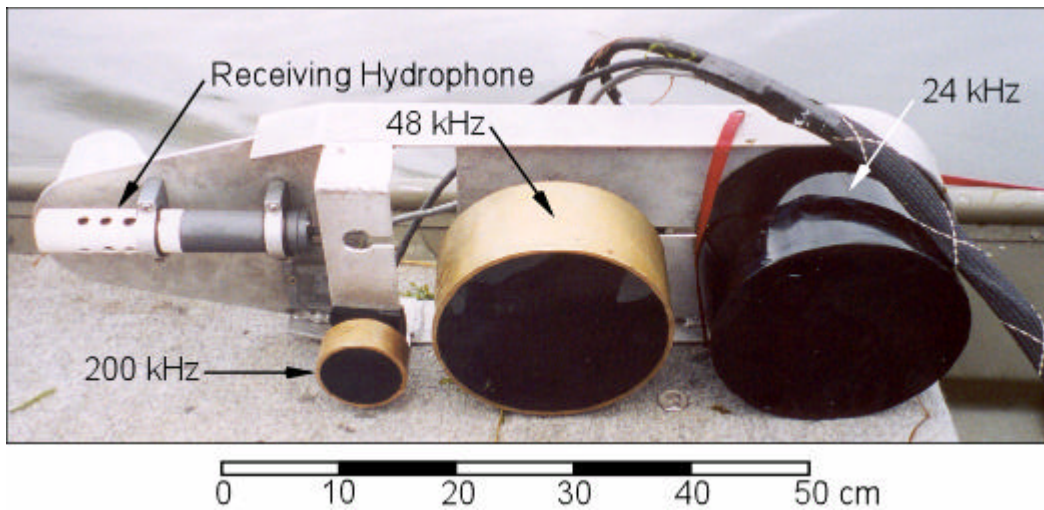
Figure 3-2. Picture of acoustic profiler transducer array. The profiling system produces acoustic signals with three widely separated frequencies (200, 48, and 24 kHz) in rapid succession as the profiles are traversed.

The system images the bottom and sub-bottom sediments with up to five widely separated acoustic frequencies at a time. For large reservoirs, with water depths of 5 to 50 m and sediment fill thickness of 1 to 10 m, acoustic transducers with central frequencies of 200, 48, 24, 12, and 3.5 kHz are used. During acquisition the system collects traces using each transducer independently in rapid succession in round-robin fashion. The high-frequency signals provide a sharp image of low-density fluid mud at the water bottom, whereas the low-frequency signals penetrate many meters of sediment to image the base of sediment fill, even in areas of high sediment accumulation. The limitation of the 12 and 3.5 kHz transducers is that they require a minimum of 3 to 5 m of water depth to produce usable records while adding significantly to the weight of the sound source (50 kg). The 24 and 48 kHz transducers require 1 to 2 m of water depth to produce usable records. For the present applications, acoustic transducers with central frequencies of 200, 48, and 24 kHz were used (Figure 3-2).

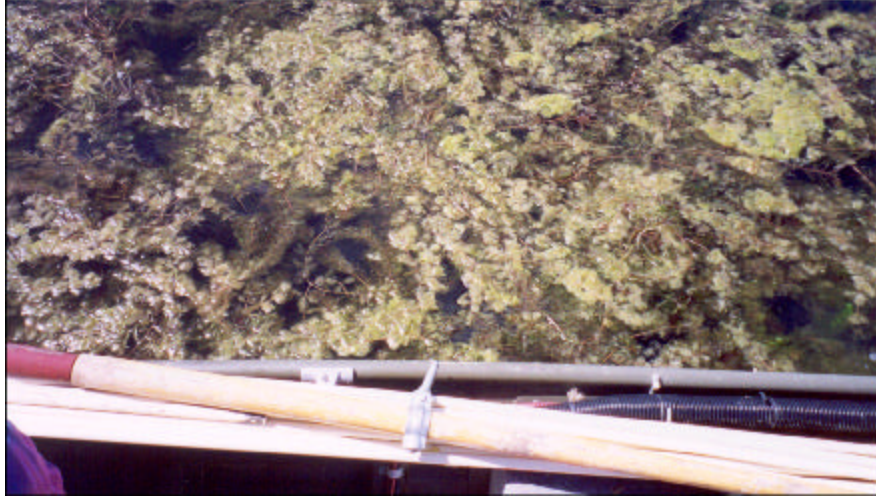
Figure 3-3. Picture of aquatic vegetation. Both White Mound Lake and Twin Valley Lake contain vegetation that extends from the water bottom to the surface in areas of 4 m water depth and less. The vegetation scatters the 200 kHz acoustic signals.

An additional surveying difficulty was caused by the occurrence of thick aquatic vegetation in areas of the reservoirs with 4 m of water depth or less (Figure 3-3). During the surveys, the weeds fouled the outboard propeller and transducer array. It was discovered during post-processing, that the vegetation efficiently scatters high frequency sound, making the 200 kHz data useless in heavily vegetated areas. Fortunately, the vegetation was nearly transparent to the 48 kHz signal. Hence, the water bottom was traced using the 48 kHz data alone in the vegetated areas.

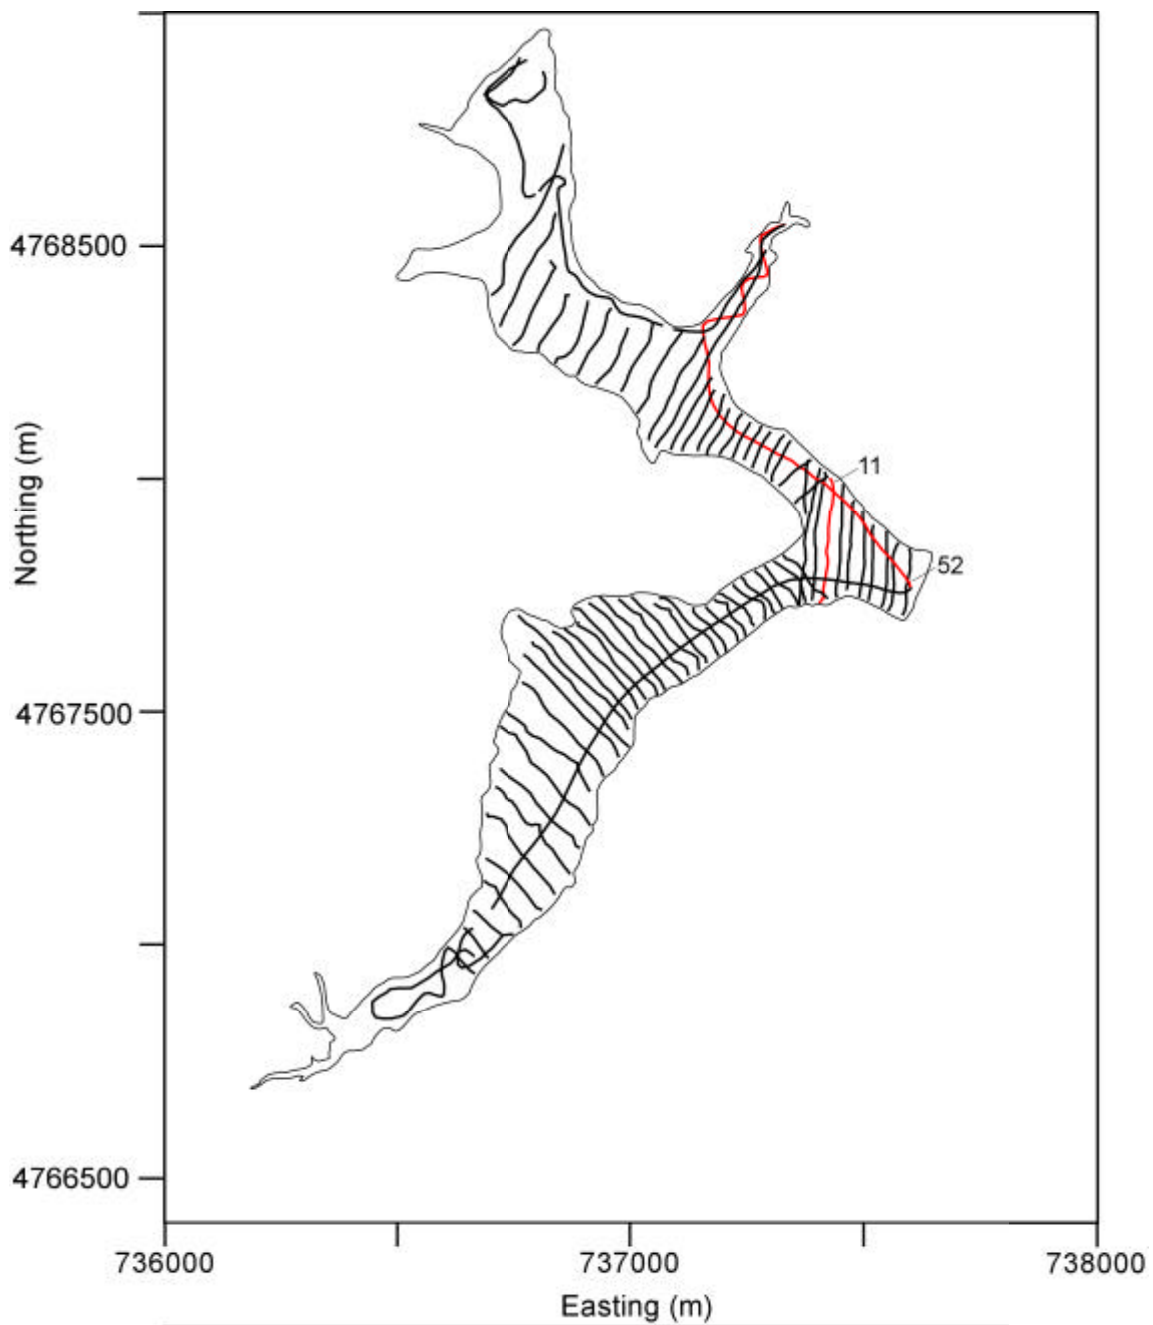
Figure 4-1. Profile map of Twin Valley Lake acoustic survey. The survey contains 17 km of profile lines. Profiles 11 and 52, highlighted in red, are shown as example profiles in accompanying figures. Coordinates are in meters (UTM Zone 15).

The survey of Twin Valley Reservoir was conducted on May 30, 2002. The survey began by collecting track lines across the main body of the reservoir near the dam at 25 m spacing. Line-spacing was then switched to 50-m for the tributary arms, in order to complete the survey in one day (Figure 4-1).

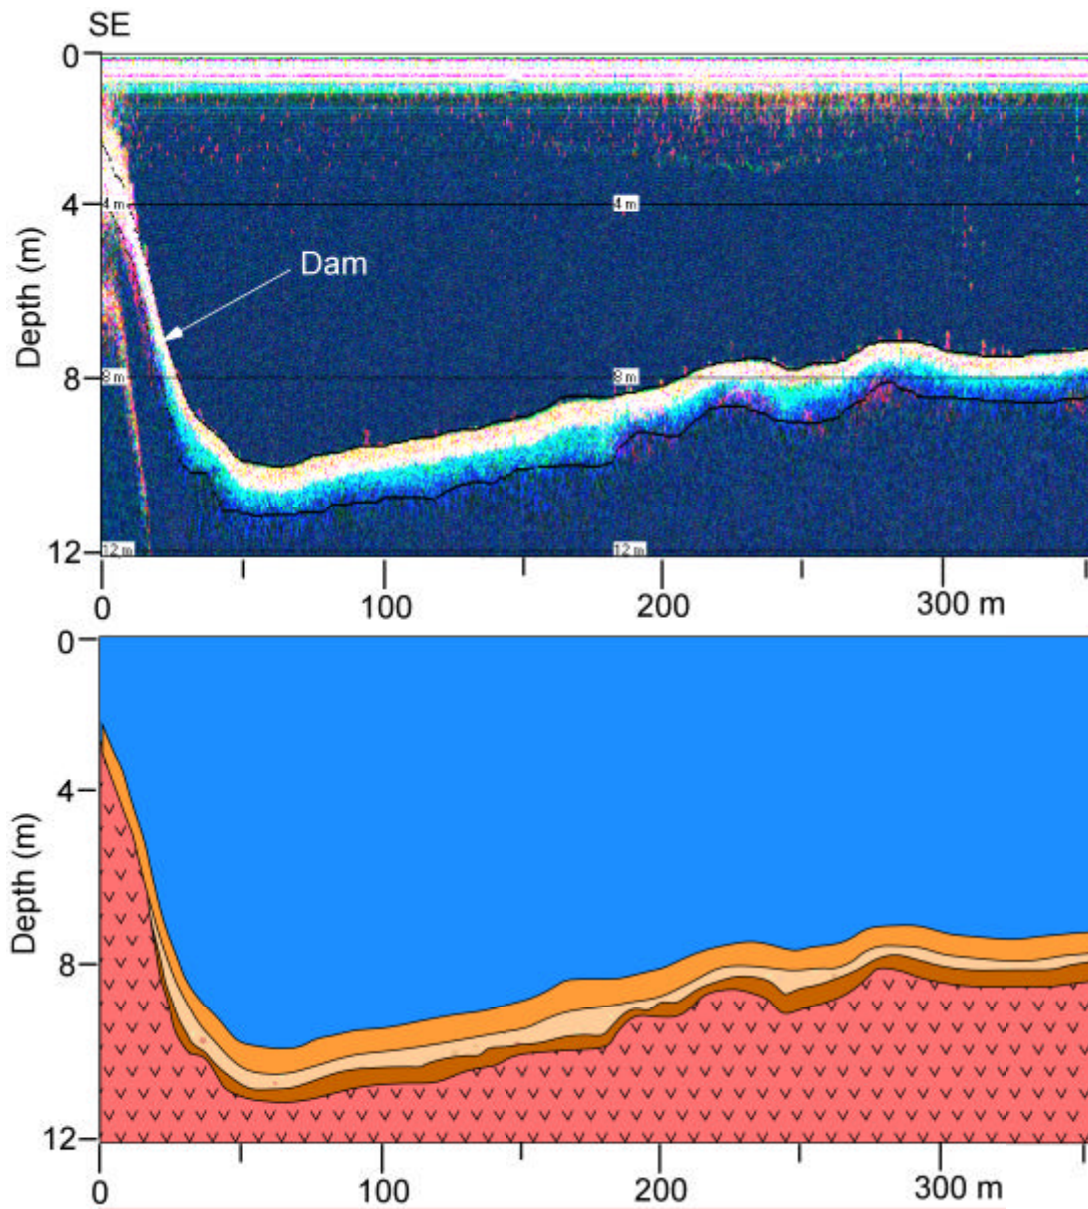
Figure 4-2. Southeast end of Twin Valley Lake axial profile, Line 52 (see Figure 4-1 for line location). Three acoustic intervals are seen within the sub-bottom in Twin Valley Lake. All three onlap onto the dam face. Hence, all three must be part of the post-impoundment sediment fill package.

The acoustic response of sediments onlapping the dam face show three distinct acoustic layers (Figure 4-2). The upper-most layer appears white on the multifrequency displays, indicating scattered returns from all three frequencies. Such a response commonly corresponds to fine-grain, water-rich sediments. This layer has a nearly uniform thickness, 0.3 to 0.4 m, throughout the reservoir and appears to drape bottom topography. The layer beneath the first appears light blue in the false-color display, indicating returns from the 48 and 24 kHz signals, but not the 200 kHz. This interval preferentially fills the lows and channel axes, is 0.6 m thick near the dam, and thins upstream (Figures 4-2 and 4-3). In the upper reaches of the tributary arms, the light blue layer is only present at the base of the channel axes. The bottom-most layer deposited on the dam face appears dark blue, indicating returns from only the 24 kHz signal. This interval is relatively thin (0.1 to 0.2 m) over most of the reservoir, but reaches considerable thickness in the channel axes.

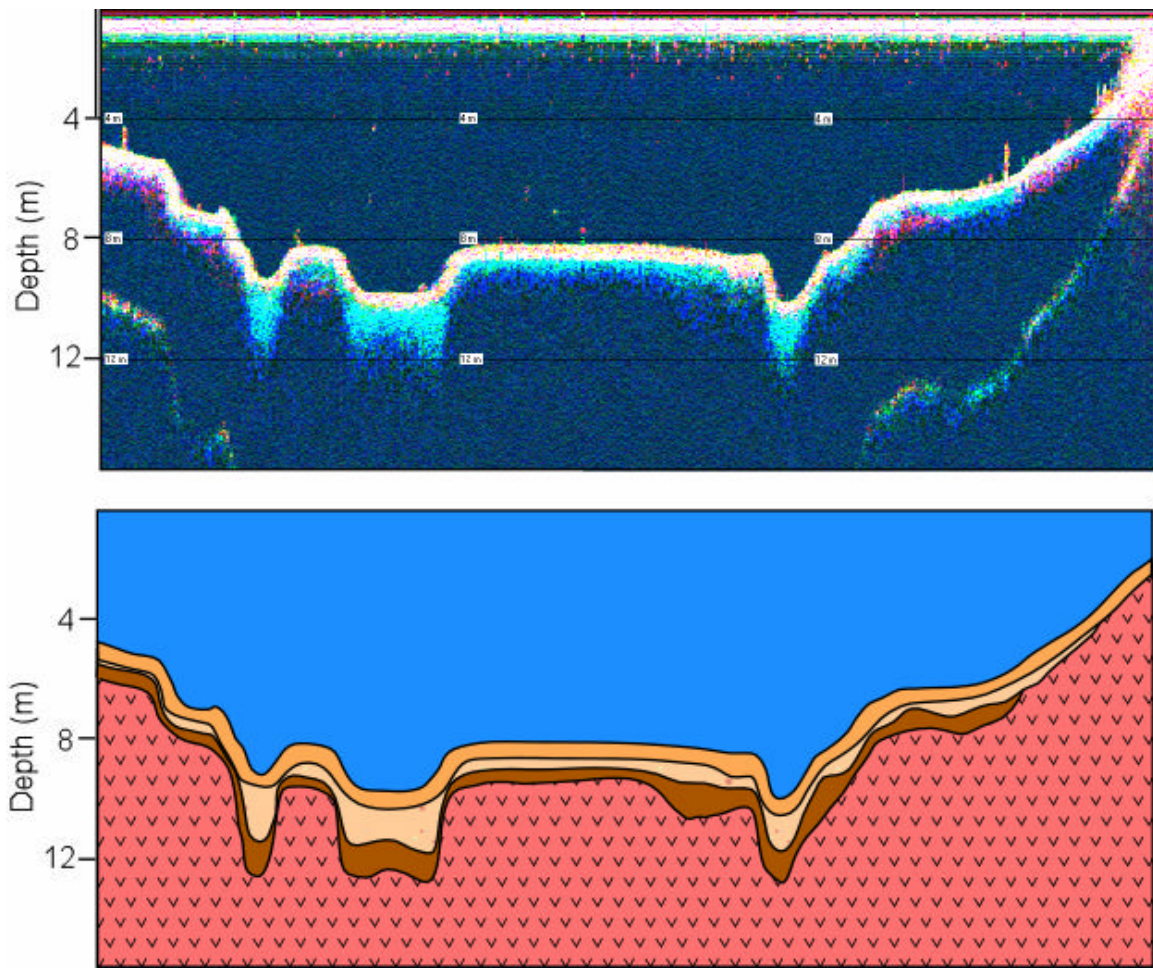
Figure 4-3. Processed Line 11 with interpretation (see Figure 4-1 for line location). The multifrequency acoustic profiles show three distinct sediment layers within the post-impoundment fill.

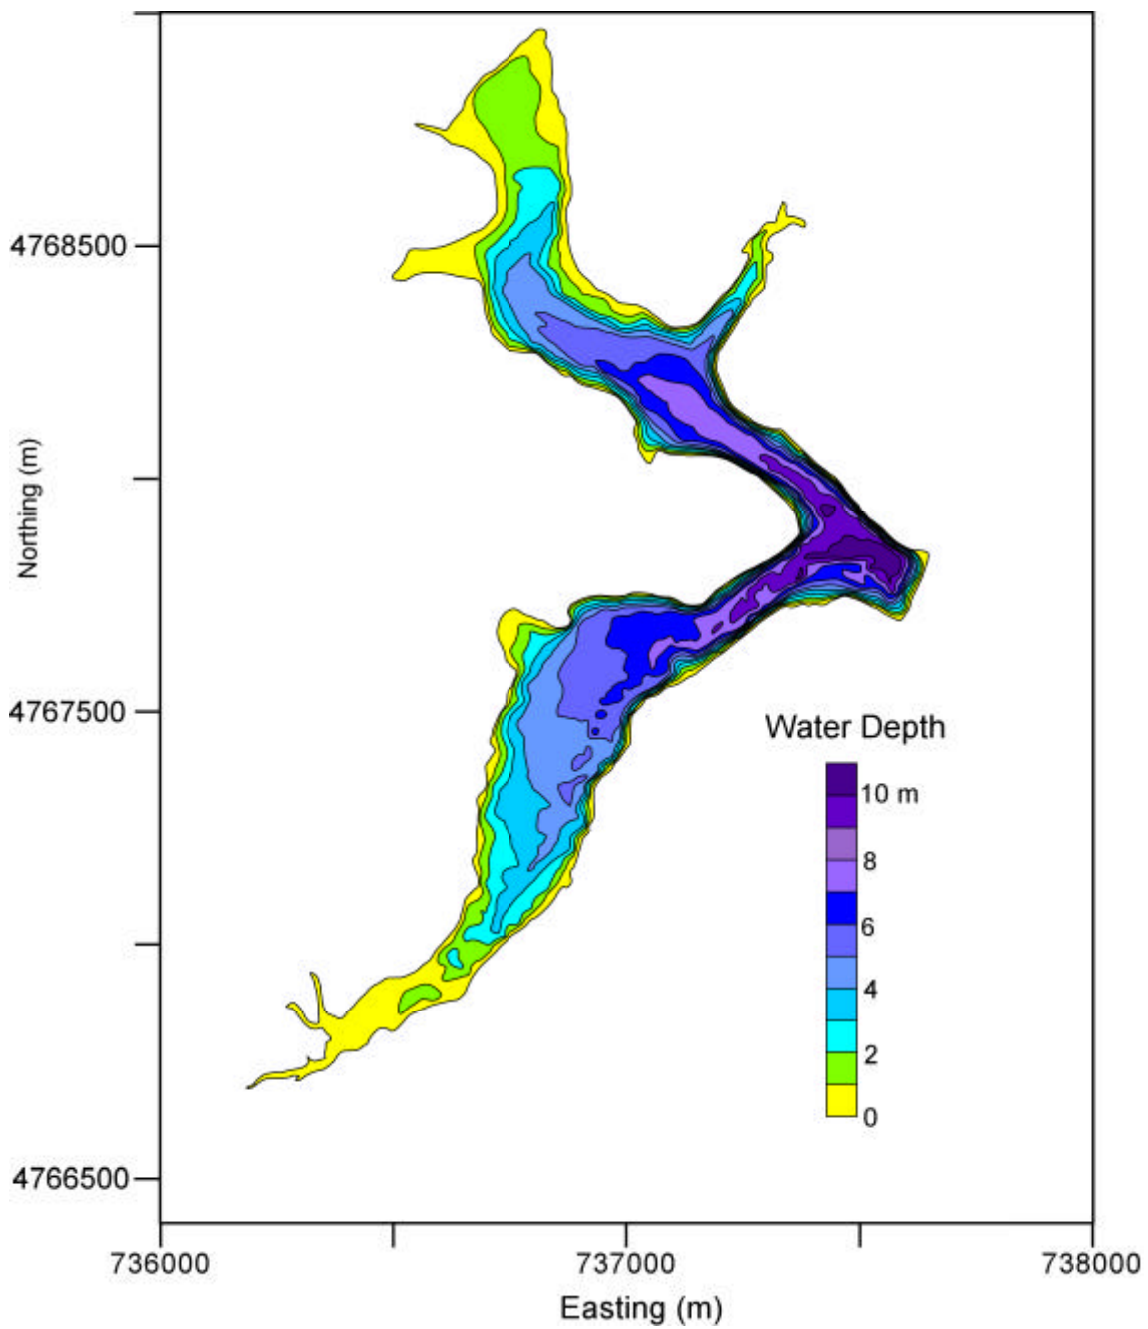
Figure 4-4. Contour map of water depth in Twin Valley Lake, WI. Depth is measured from the water surface at an elevation of 277.4 m (910 ft). Coordinates are in meters (UTM Zone 15).

The resulting map of the water depth indicates a maximum depth of 10.2 m (33.4 ft) near the dam and a total current water capacity of 2,089,500 m³ (1693.6 acre-ft; Figure 4-4). The sediment isopach map indicates a maximum thickness of 3.1 m, in a small area along the main channel axis, and a total volume of post-impoundment sediment of 458,659 m³ (371.8 acre-ft; Figure 4-5).

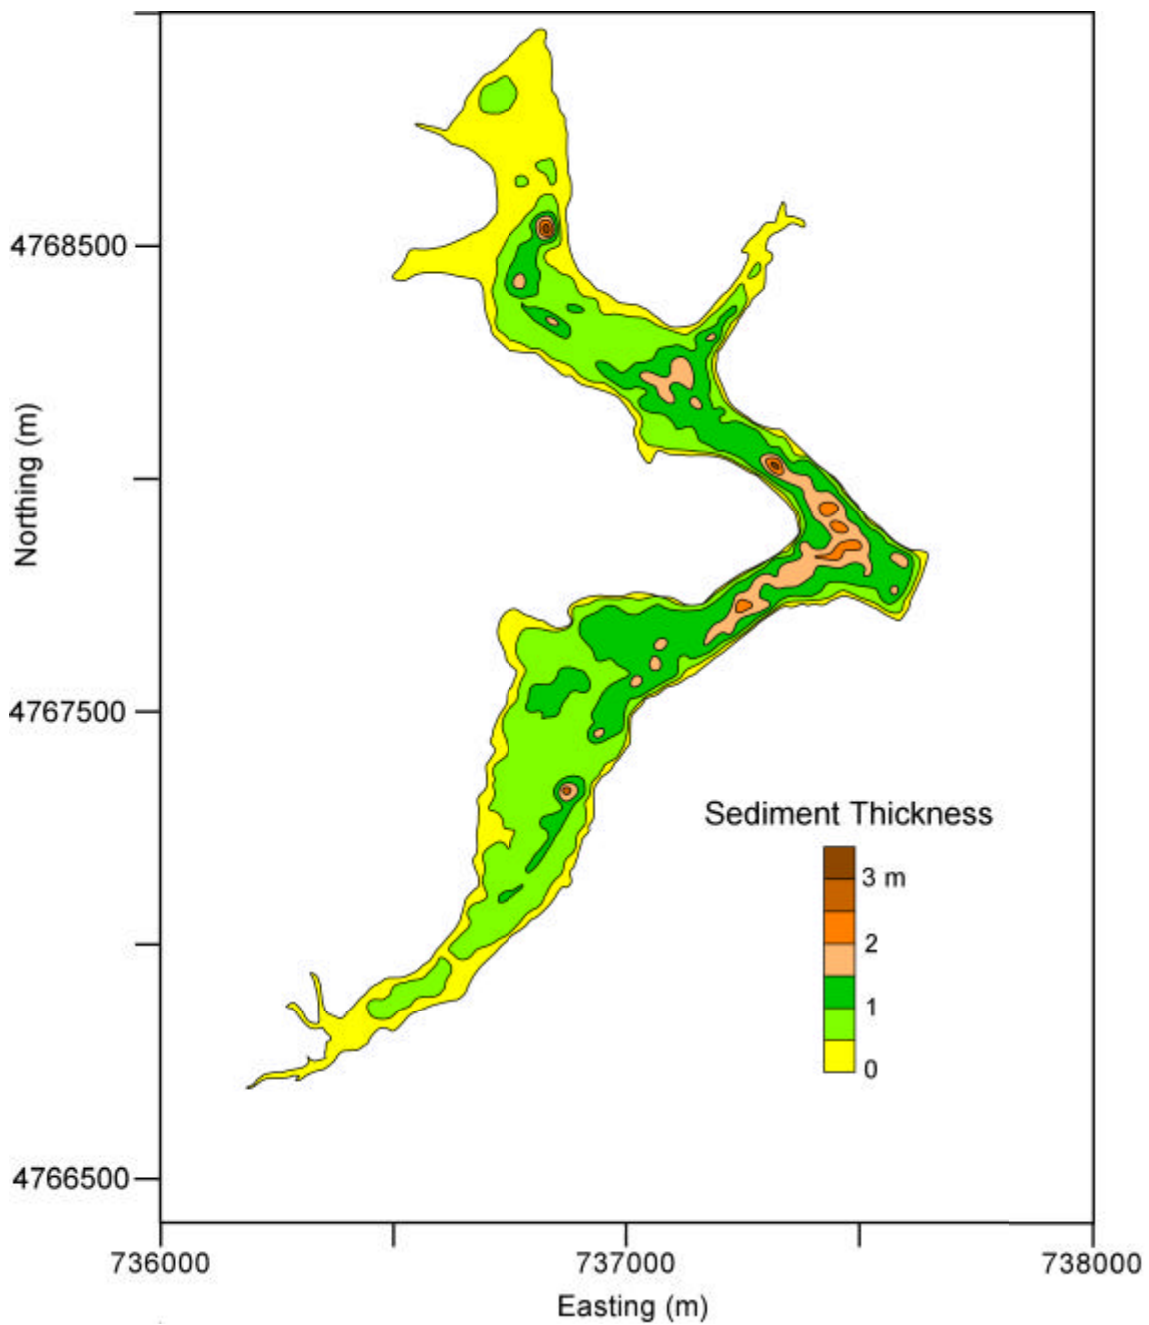
Figure 4-5. Contour map of sediment thickness in Twin Valley Lake, WI. Sediment thickness is measured from the water bottom to the interpreted base of post-impoundment fill. Coordinates are in meters (UTM Zone 15).

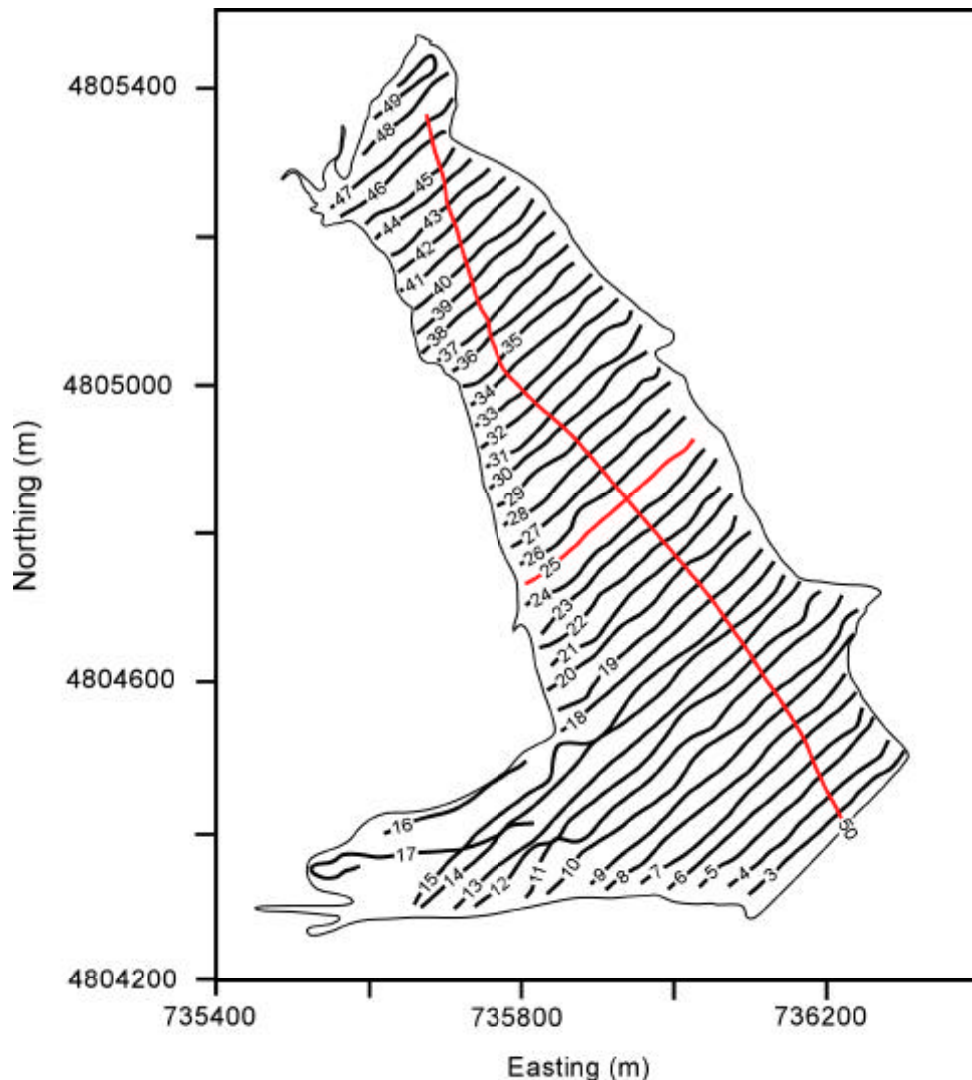
Figure 4-6. Profile map of White Mound Lake acoustic survey. Profiles 25 and 50, highlighted in red, are shown as example profiles in accompanying figures. Coordinates are in meters (UTM Zone 15).

White Mound Reservoir was surveyed on May 31, 2002. The entire survey was conducted with a 25-m track line spacing (Figure 4-6). Acoustic intervals similar to those seen in Twin Valley Lake were observed in White Mound Lake onlapping onto the dam face (Figure 4-7) and thinning upstream (Figure 4-8). The resulting maps indicate a maximum water depth of 8.6 m (28.3 ft) and a current water storage capacity of 1,462,460 m³ (1,185.4 acre-ft; Figure 4-9). The sediment thickness map indicates a maximum thickness of 1.4 m (4.6 ft) and a total volume of post-impoundment sediment of 203,205 m³ (164.7 acre-ft; Figure 4-10).

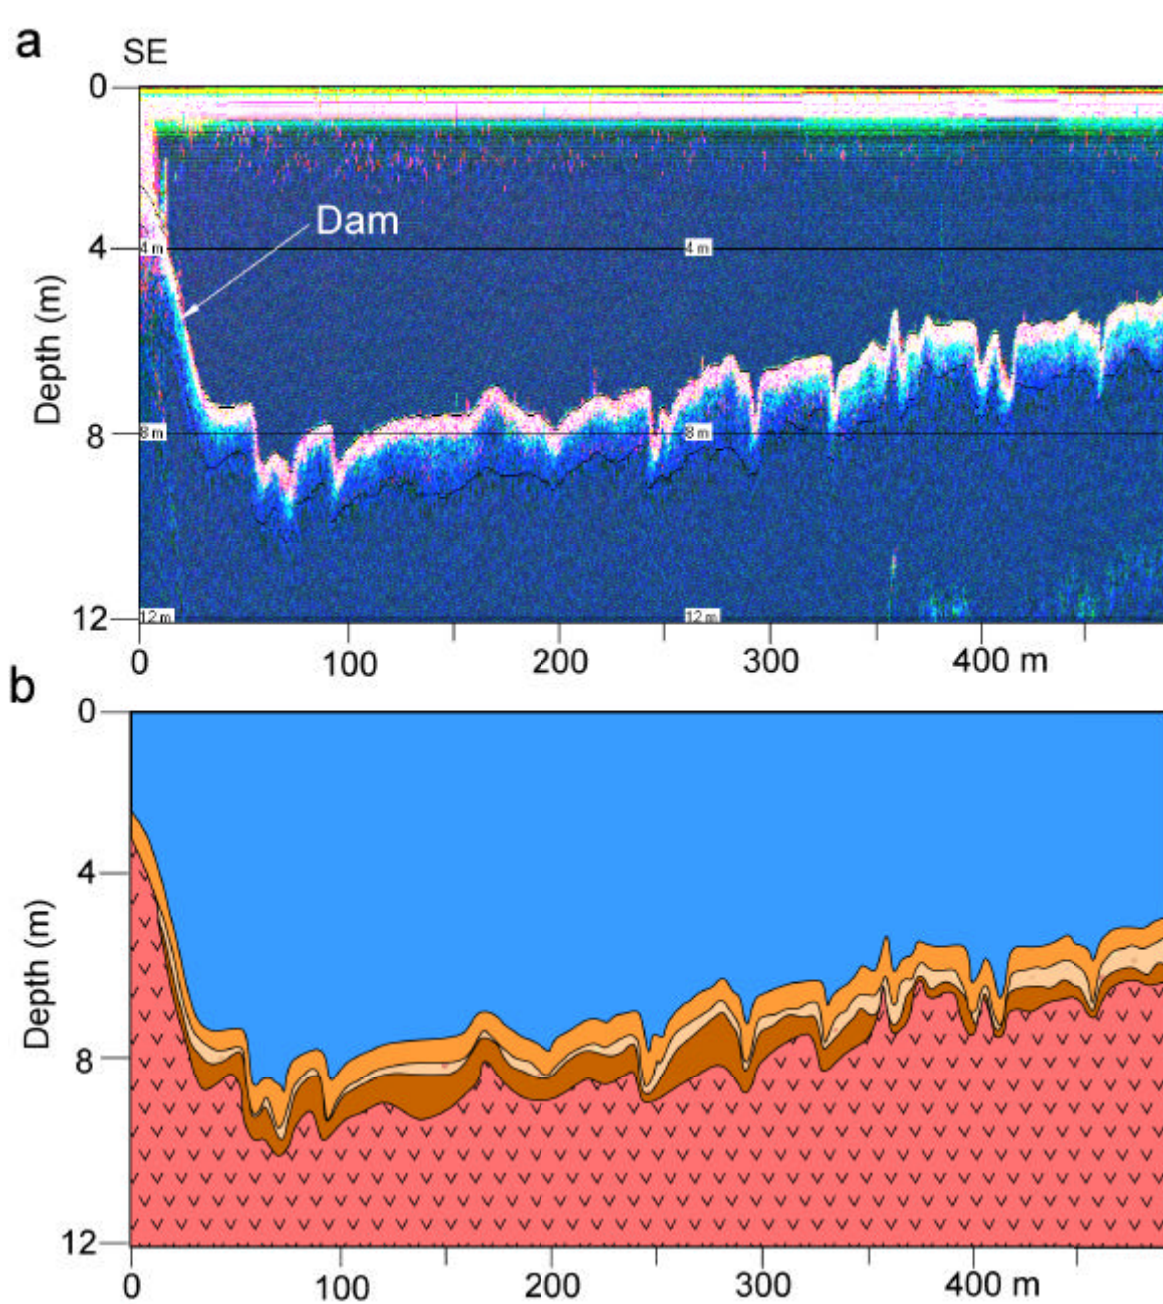
Figure 4-7. Southeast end of White Mound Lake axial profile, Line 50 (see Figure 4-6 for line location). Three acoustic intervals are seen within the sub-bottom in White Mound Lake. All three overlap onto the dam face. Hence, all three must be part of the post-impoundment sediment fill package.

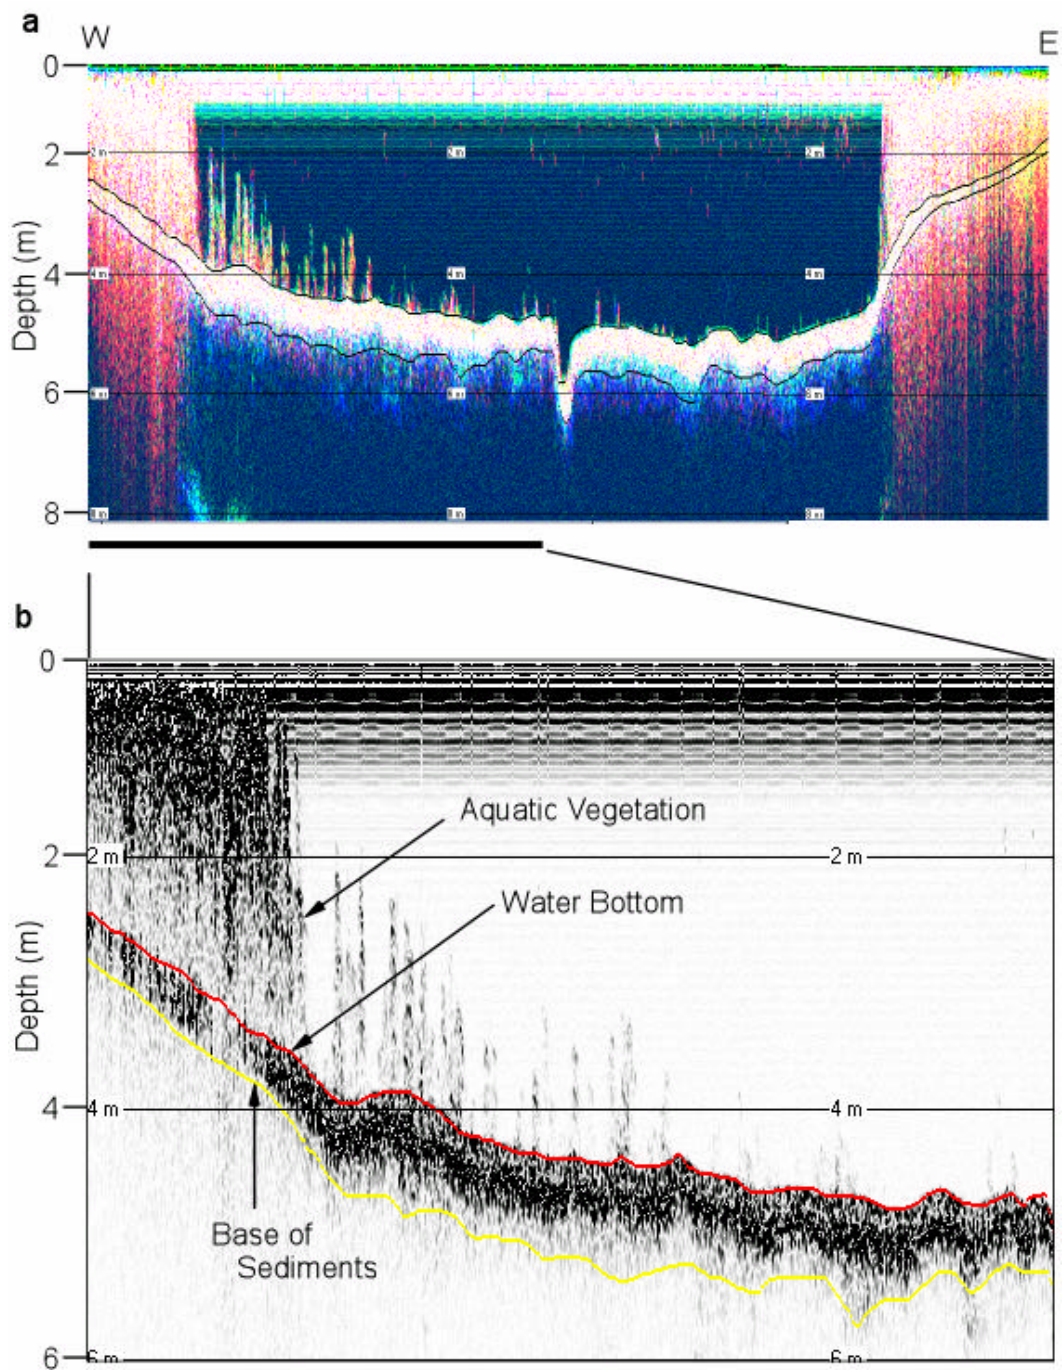
Figure 4-8. Acoustic profile 25 of the White Mound survey (see Figure 4-6 for line location). (a) Multifrequency display in which 200 kHz is red, 48 kHz in green and 24 kHz is blue intensity in the RGB image. The interpreted top and base of the post-impoundment fill are marked with black lines. (b) Aquatic vegetation blocks the 200 kHz signal, but is relatively transparent to the 48 kHz signal.

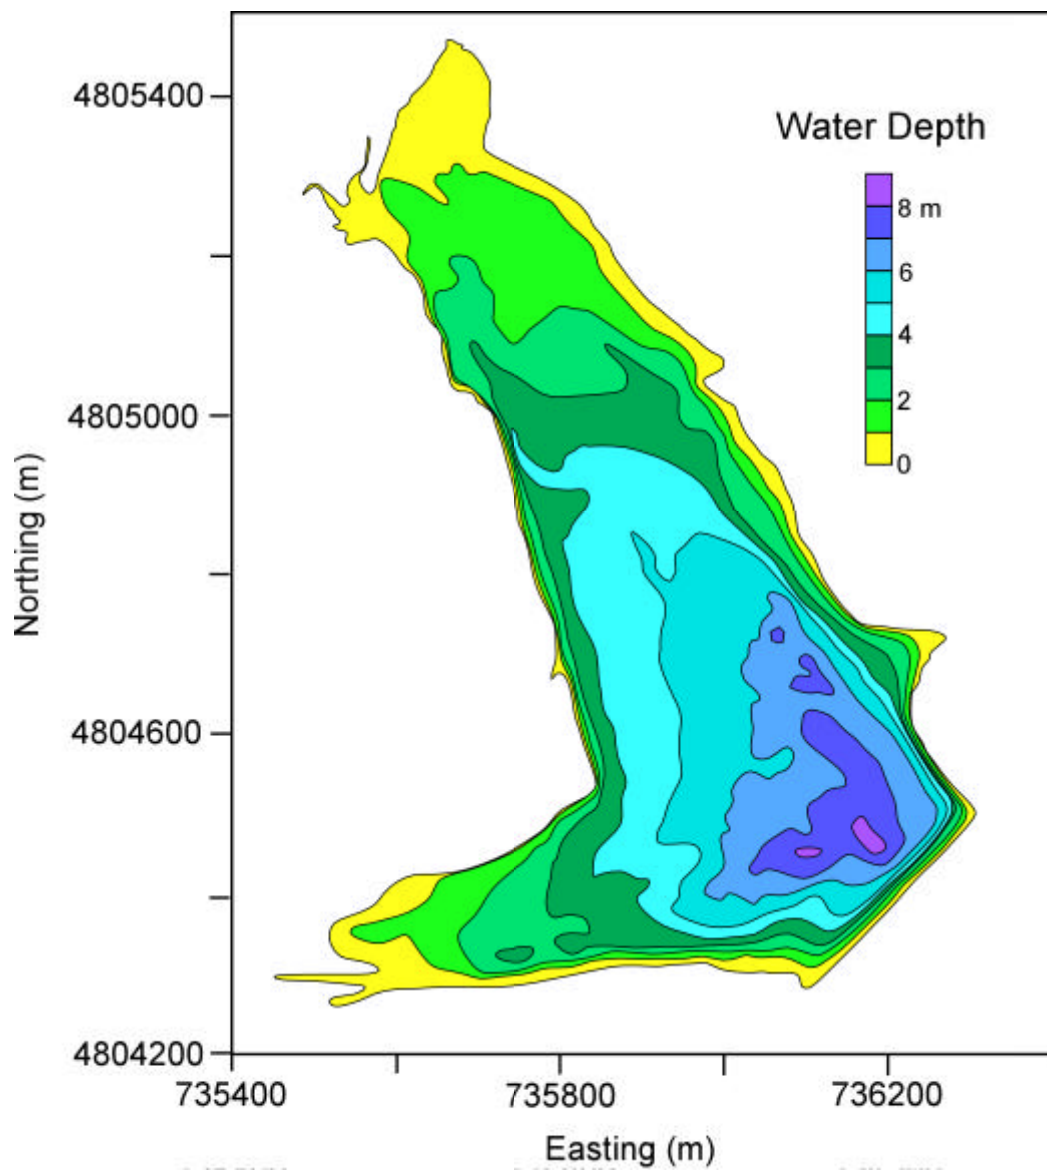
Figure 4-9. Contour map of water depth in White Mound Lake, WI. Depth is measured from the water surface at an elevation of 278.4 m (913 ft). Coordinates are in meters (UTM Zone 15).

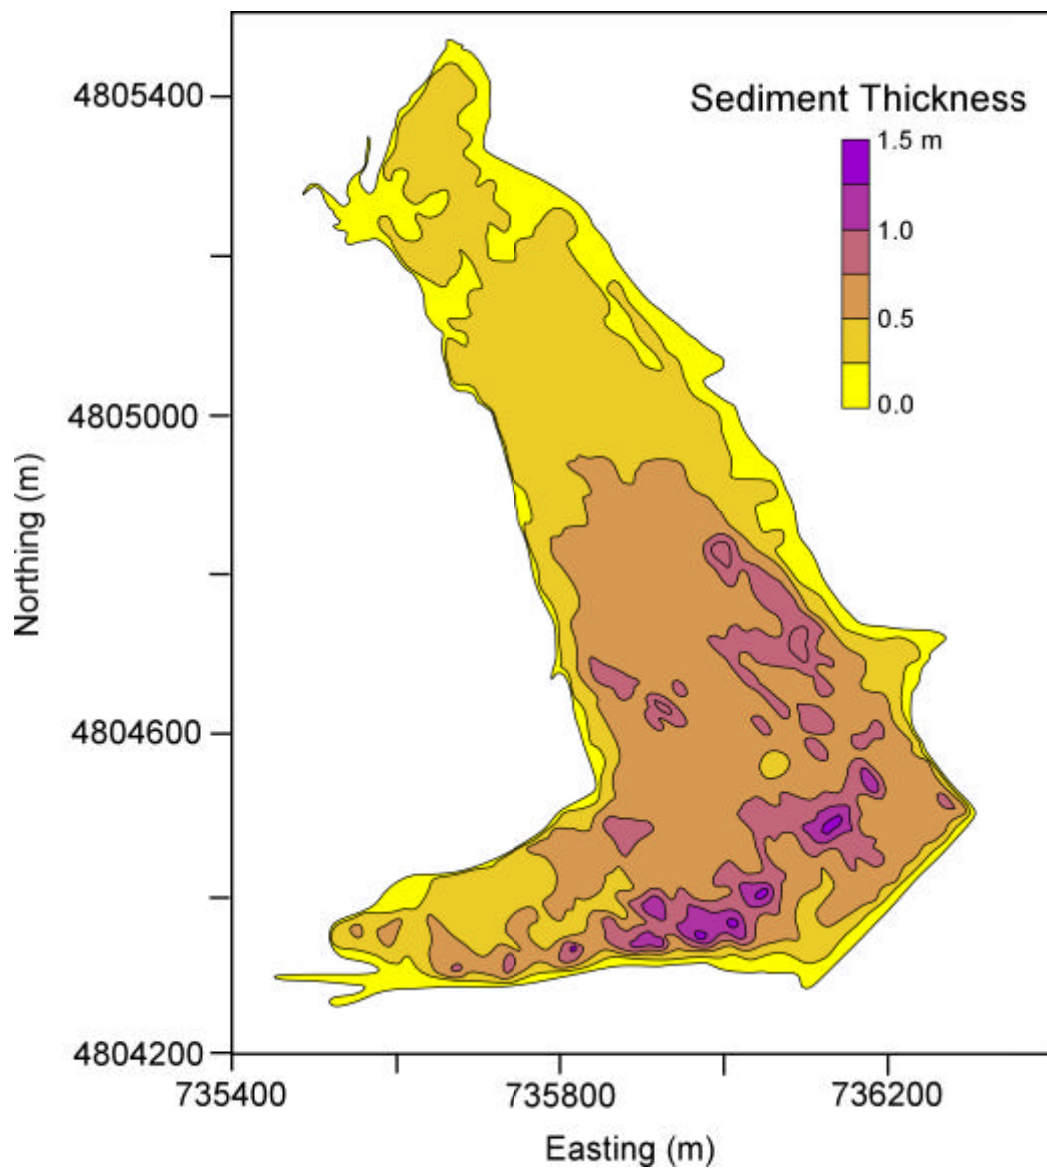
Figure 4-10. Contour map of sediment thickness in White Mound Lake, WI. Sediment thickness is measured from the water bottom to the interpreted base of post-impoundment fill. Coordinates are in meters (UTM Zone 15).
